## GBG Australia

## Applications for THERMOGRAPHIC IMAGING

## Non-Destructive Techniques THERMOGRAPHIC IMAGING

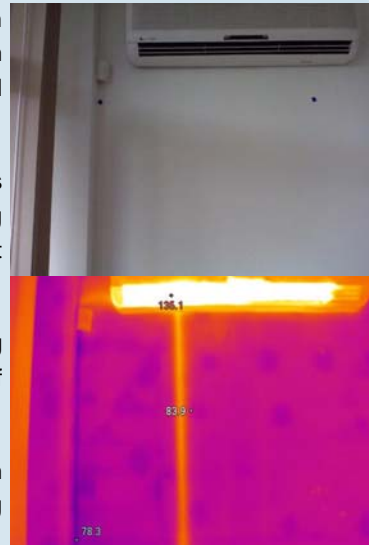
A PIPE LEADING FROM AN AIRCONDITIONER UNIT SHOWING A CLEAR THERMAL DIFFERENCE.

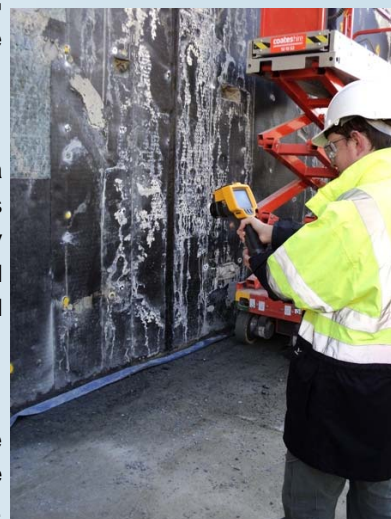
A THERMOGRAPHIC IMAGE BEING TAKEN

During the survey a series of thermographic images were taken on each wall in a 1m x 1m grid. Any anomalies located were marked on site. Sufficient heating/cooling was required to ensure good thermal differential, therefore scans were performed during early morning and early evening to ensure the thermal difference between the concrete and anomalies was at its greatest. High frequency radar was also undertaken in selected sections to determine the accuracy of the thermal imaging results.

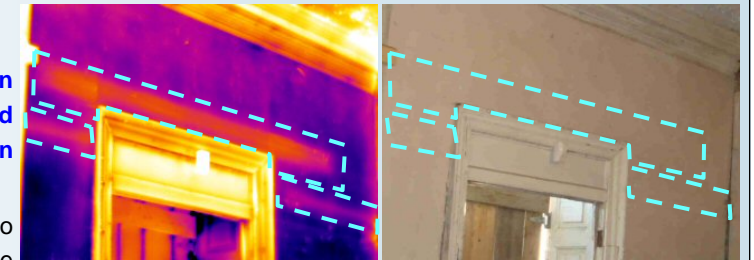
FRONT DOOR - HOTTER (LIGHTER) RESPONSES HIGHLIGHTING THE POSITION OF THE INTERIOR DOOR LINTEL, AND ALSO TIMBER INSERTS BELOW

The thermal imaging recorded some stucco patch work on the walls that appear cooler as a striking contrast in the typically hotter background which means that the repair stucco is thicker than the original stucco. Increased moisture levels in some areas of the walls appear cooler than the surroundings and are shown as dark patches. Some internal timber inserts were identified behind the plastered finishes.

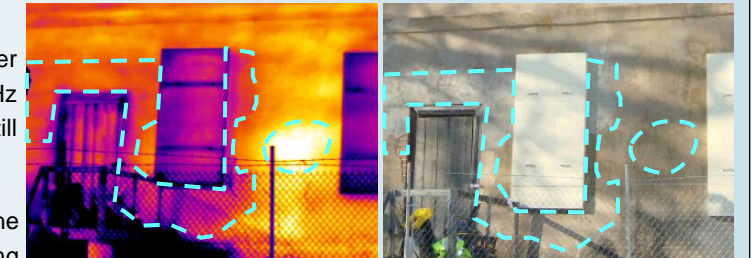
COOLER RESPONSE HIGHLIGHTING PATCH REPAIR AROUND WINDOWS.

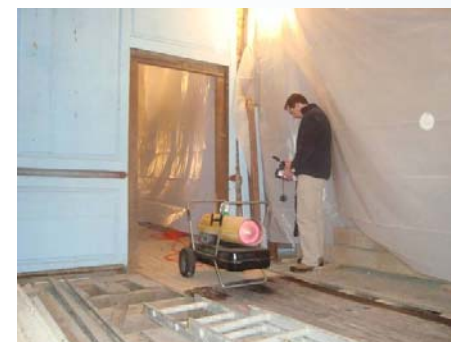
THERMAL IMAGING FROM INTERIOR

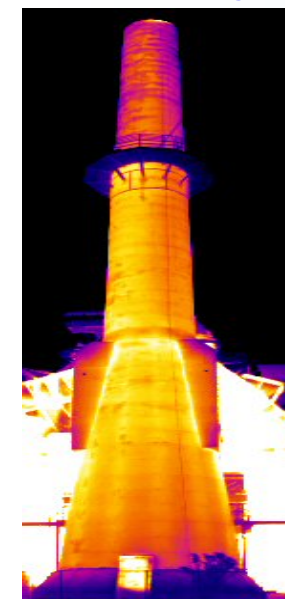
THERMAL IMAGE OF CHIMNEY

The structure composed is composed of a mild steel inner liner covered with refractory bricks and coated with a reinforced concrete windshield exterior. There is concern that over time breaches in the interior brick lining have occurred threatening the stability of the concrete windshield.

Thermal imaging is an appropriate technique to assess the condition of the brick lining and concrete windshield. The hot gases through holes & cracks in the brick cause localised heating in the concrete windshield which can easily be detected through with a thermographic camera. Comprehensive mapping of the chimney was achieved by scanning the full height of the structure from different perspectives.

Imaging was done when the chimney was in use to provide the best possible results. It was found the chimney produced an overall cool thermal response with clusters of hotter thermal responses. Hotter responses are related to potential breaches in the brick lining, the hot spots were relatively minor in size and were localised. Due to this it is believed that systematic failure of the entire structure was unlikely. The cooler overall response however suggests more widespread failure of the reinforced concrete windshield as the result of delamination and spalling.
